**GEOLOGICAL AND GEOPHYSICAL FIELD INVESTIGATION  
DEER CREEK LAKE**

*Plymouth County, Iowa*

**IOWA DEPARTMENT OF NATURAL RESOURCES  
- LAKE RESTORATION SECTION -**

September 6, 2012

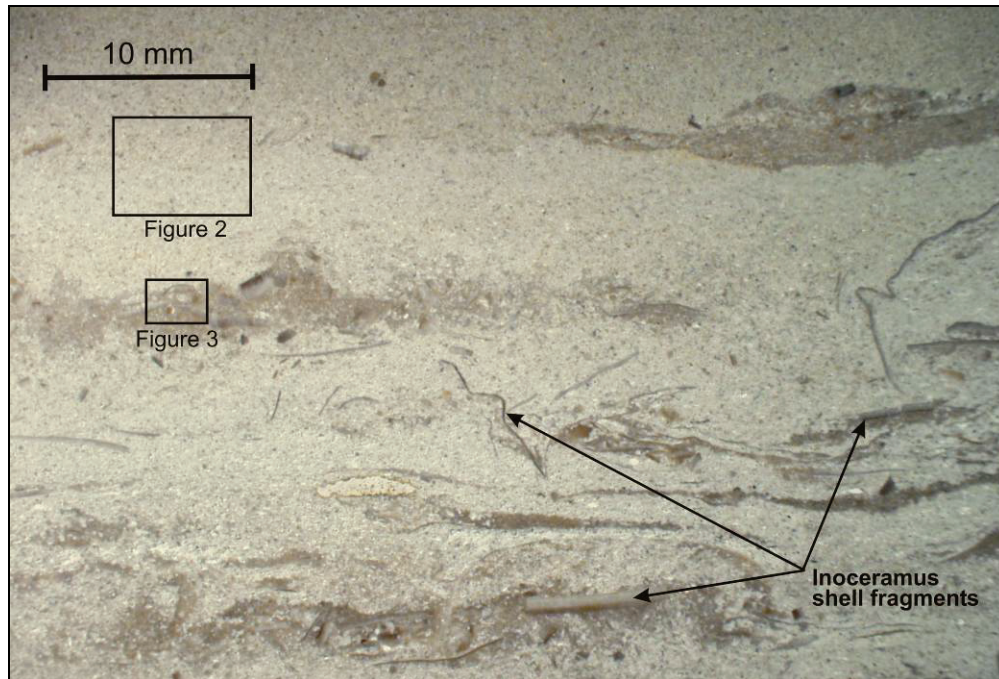
The rock sample collected from the seep was cut and slightly polished in order to gain the best cross sectional view of the rock (Figure 1). This rock is a tan-yellow, very fine grained to microcrystalline argillaceous limestone and part inoceramite packstone. This rock also exhibits up to approximately 30% porosity (Figure 2) as noted by abundant pore spaces between the grain boundaries.

**Figure 1.** Slab cut from limestone sample collected at the mouth of the seep. Note distinct zones of inoceramus shell debris mixed with clay surrounded by fine grained matrix. The image is oriented such that up is toward the top of the page.

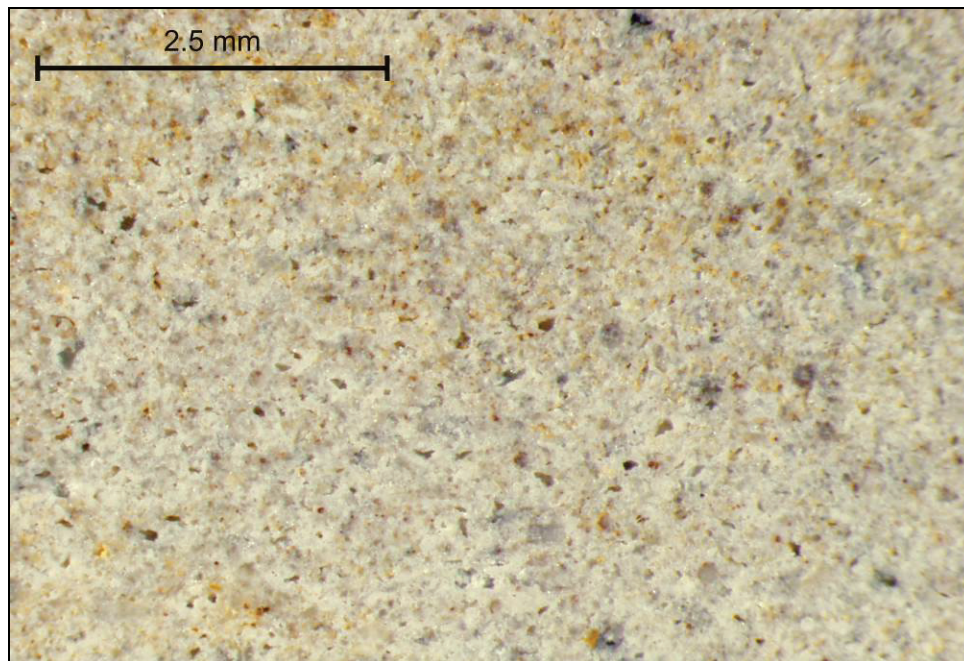
**Figure 2.** Close up view showing abundant pore spaces within the microcrystalline texture of the limestone sample. The primary component of this rock is minute shell fragments and calcite crystals.

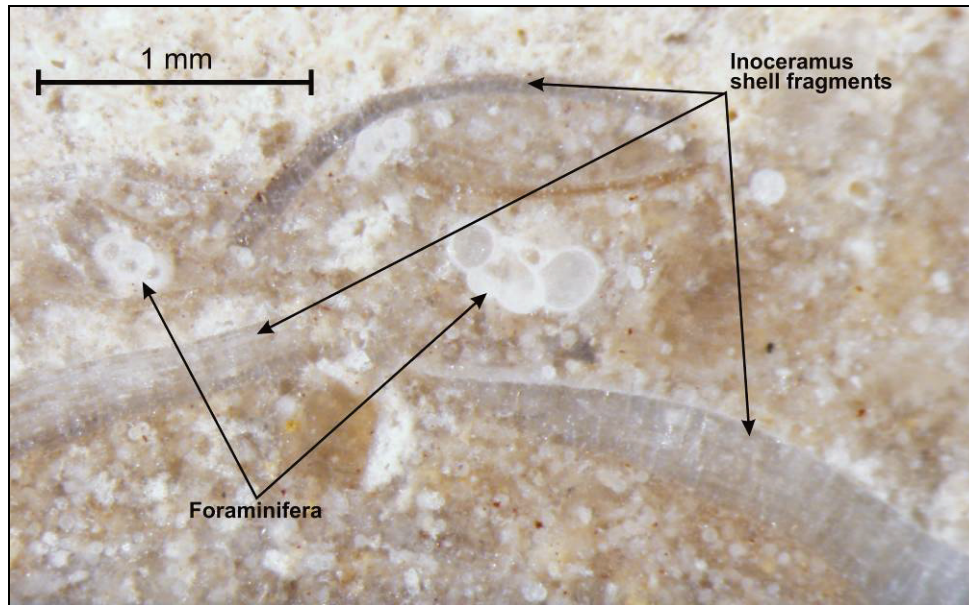
Foraminifera are also abundant in this rock (Figure 3), primarily concentrated in zones where shell fragments have accumulated.

**Figure 3.** Close up view of accumulation zone of shell fragments and foraminifera fossils. These zones also show increased clay content versus the less fossiliferous zones.

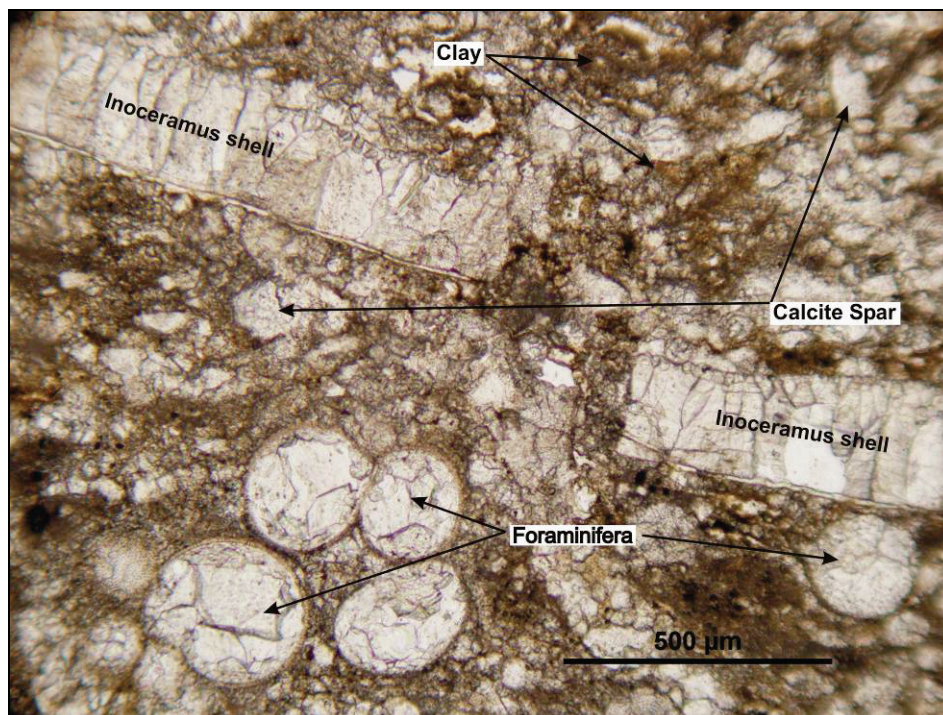
Microscopic analysis of a thin section made from this rock sample reveals the true abundance of calcite crystal fragments, shell debris, and foraminifera fossils that make up the limestone unit of the Greenhorn Limestone in the area of the seep (Figure 4).

**Figure 4.** Photograph of thin section taken from same sample as Figure 1. The inoceramus shell fragments have been completely recrystallized with calcite as is the case with the foraminifera fossils (scale 500  $\mu\text{m}$  = 0.5 mm).

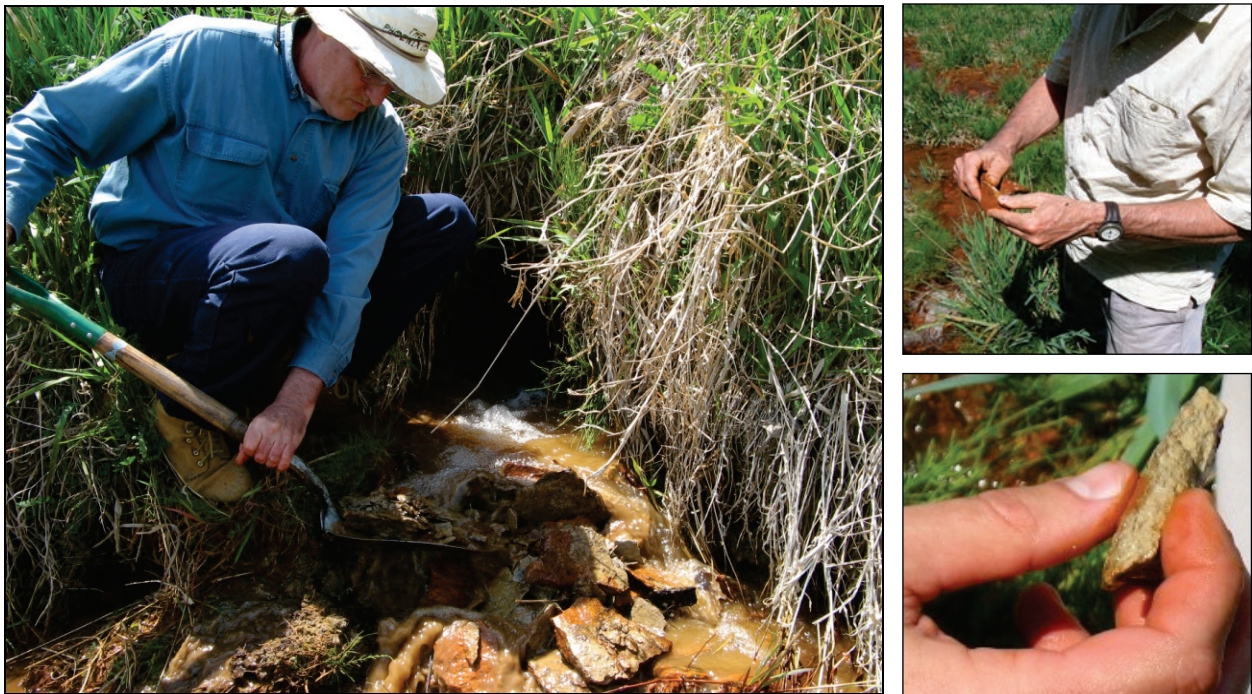
**Figure 5.** IGWS geologist exposes and examines the seep south of the dam. Images to the right show the limestone hand samples collected from the seep.

Figure 5 shows the observed seep southwest of the dam (see Appendix I for location). After removing vegetation and exposing the seep, visible signs of chemical dissolution and fracturing were observed in the exposed Greenhorn Limestone. A probable scenario is that this near surface carbonate formation had fractures along natural bedding planes and/or joints that have been enlarged by shallow groundwater flow.

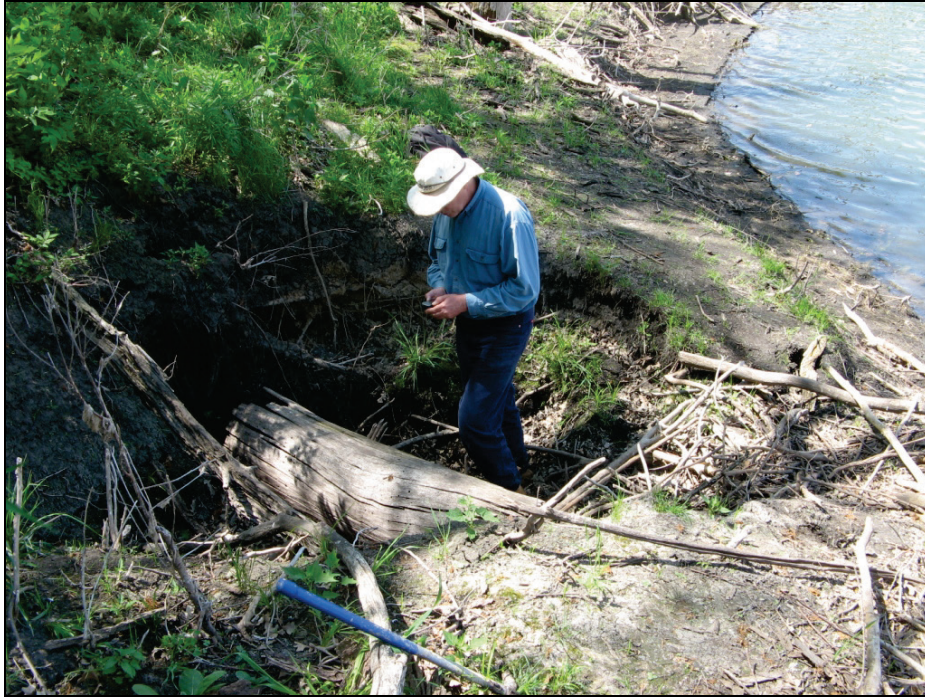
**Figure 6.** Image of sinkhole feature.

A closed depression that indicates a possible dissolution cavity, or sinkhole (Figure 6), was identified near the south-central shore of the lake (see Appendix I for location). This feature is lower in elevation than the high water line, and was within two feet of the lake level at the time of field work. A borehole log from GSI boring BH-2, located approximately 100 feet SSW of the sinkhole feature, indicates limestone from the Greenhorn Limestone occurring at an elevation of approximately 1,231 feet asl. Similarly, the Survey A electrical resistivity model (Appendix IV) indicates a bedrock high in that area (see discussion below). Additionally, nearby GSI boring BH-3 lists a bedrock elevation of 1,233 feet asl. Lake water surface has reached an elevation of at least 1,239 feet asl based on IDNR LiDAR data gathered from December 2008, and possibly higher based on shoreline observations. A cross-sectional view of the geologic units west of the DCL dam is given in Appendix III. It can be determined that limestone units of the Greenhorn Limestone are in close proximity to the lake, especially on the southern shore. There may be countless other pathways such as the observed sinkhole feature through which water may travel hidden beneath the shoreline and/or lake sediments. The hydraulic head pressure from the lake likely puts stress on these bedrock voids, allowing groundwater flow to increase dramatically during times of high water level until equilibrium is reached.

voids in a limestone unit of the Greenhorn Limestone. Hand samples of the carbonate rock were examined in the field and collected for further analysis. During the site survey, a closed sinkhole feature was observed (Figure 6). The feature correlates to the GSI borehole BH-2 located approximately 100 feet SSW of the sinkhole feature, which indicates a limestone unit of the Greenhorn Limestone is likely within 10 feet of the feature. It is very probable that lake water is seeping through unconsolidated material into this and/or other hidden voids in the underlying limestone. While alluvial sands in the vicinity of the power lines cannot be discounted as a contributor of seepage, water moving through the limestone units of the Greenhorn Limestone by means of fracture sets, joints, bedding planes, dissolution cavities, or other void networks appears to be the main pathway for subsurface water loss from the lake.

Dye tracing would be an economical and potentially beneficial way to determine which part of the lake is more susceptible to seepage. For example, if dye was placed in or near the observed sinkhole feature, it could be determined whether that feature is contributing to seepage or not by measuring the concentration, if any, that is detected at the seep after a given time period. In addition, if time of travel could be determined it may provide insight on how large the void network is in the subsurface.

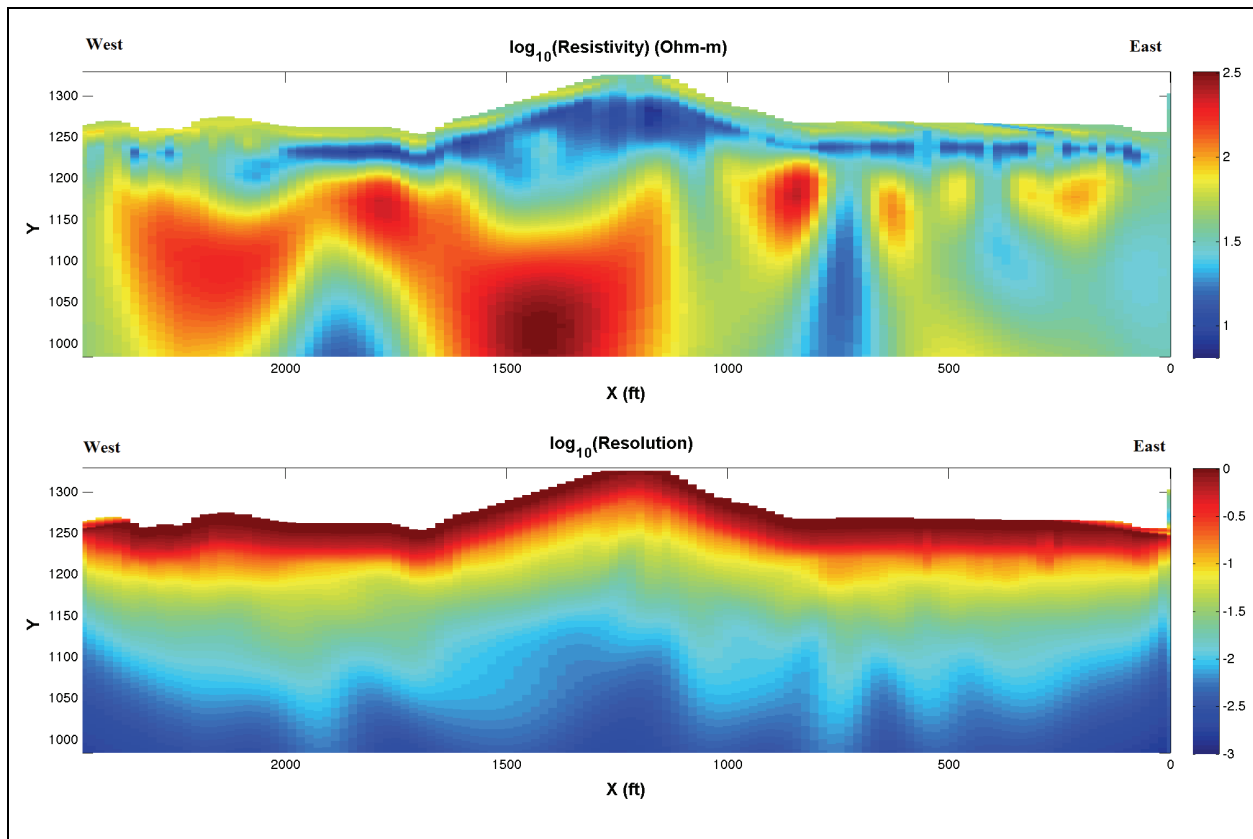
**Figure 7.** ER Survey A model (top) and associated resolution (bottom). X axis shows distance in feet. Y axis shows elevation in feet above sea level.

Figures 7 and 8 show resistivity models and associated resolution for Surveys A and B, respectively. Images are shown west to east, when viewed left to right. Pixels in model images containing resolution values less than -2.5 were not considered in this study to increase data confidence. The location for ER Surveys A and B are shown in Appendix IV. Models have been corrected for elevations at each electrode location to accurately depict topographic changes through the use of IDNR 3 meter LiDAR elevation data. Resistivity is shown on a logarithmic scale, with red representing high resistivity, and blue low resistivity.

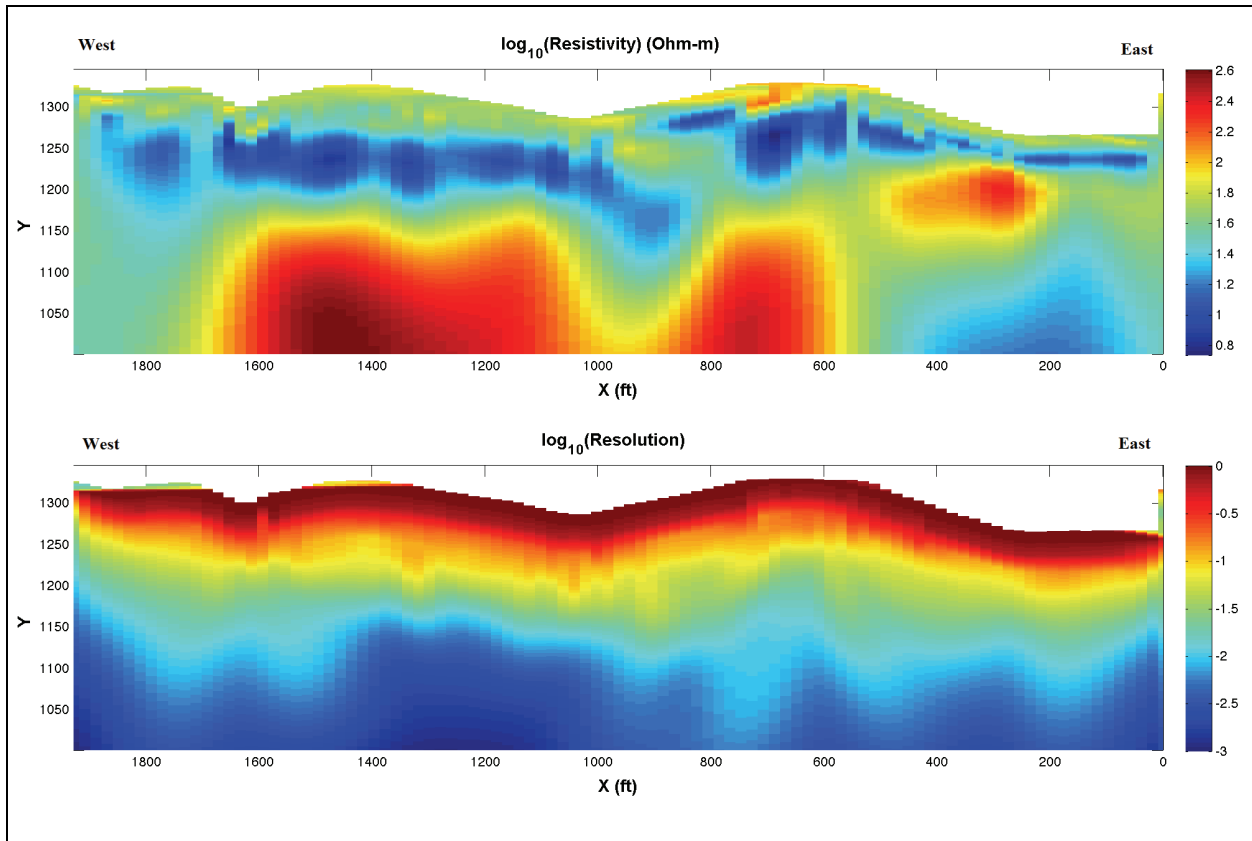
**Figure 8.** ER Survey B model (top) and associated resolution (bottom). X axis shows distance in feet. Y axis shows elevation in feet above sea level.

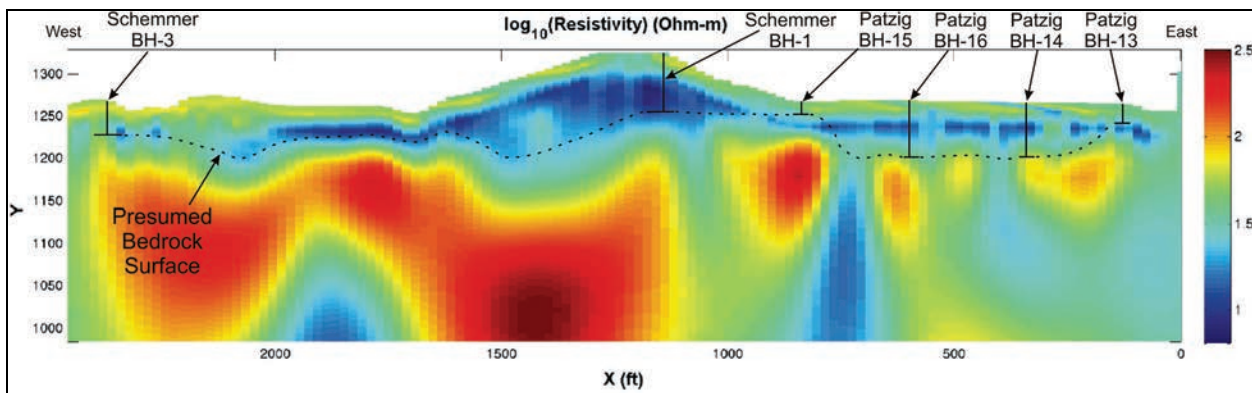
**Figure 9.** ER Survey A model with inferred bedrock surface interpretation.

Figures 9 and 10 show an interpreted bedrock surface overlaid on the ER Survey A and B models, respectively. Boreholes showing known bedrock depths used in correlation of the surface are noted above each occurrence. Although many factors can influence resistivity values, high values *generally* indicate coarse grained sediment or bedrock, while low values *generally* indicate fine grained sediments or water saturation (Burger, et. al., 2006). Through the use of electrical resistivity concepts, geologic interpretative techniques, lithologic borehole logs, and existing site information, an interpreted bedrock surface was indicated. Along both transects, this bedrock surface appears to be closest to the land surface near the observed seep. The bedrock surface appears to drop in elevation near the area of the power lines, possibly indicating an old stream channel. Models can be exaggerated, generalized, or otherwise variable, especially in areas of high resistivity or great depth. For this reason, it is difficult to make accurate interpretations at depth without data from boreholes that penetrate the entire model depth. The discontinuation of the highly resistive area generally below Schemmer boring BH-1 might represent a zone of voids with increased groundwater flow, variability in the bedrock surface, or model error. Prior to the geophysical survey, very little was known about the depth to bedrock in the area immediately around and near the power lines. Resistivity models have provided a look at how the bedrock surface depth may vary across the field area. Based on these models, it appears that the bedrock surface is closest to the land surface in an area immediately west of the dam, and east of the east parking lot.

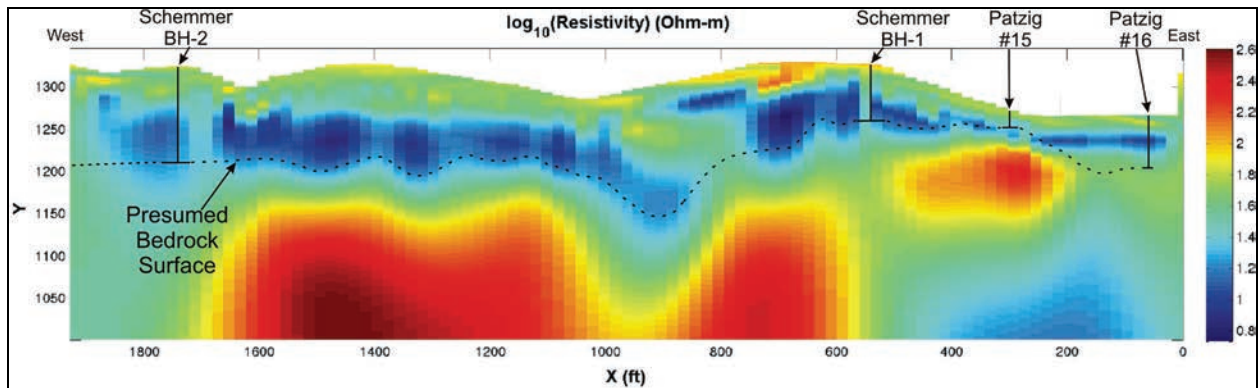
**Figure 10.** ER Survey B model with inferred bedrock surface interpretation.

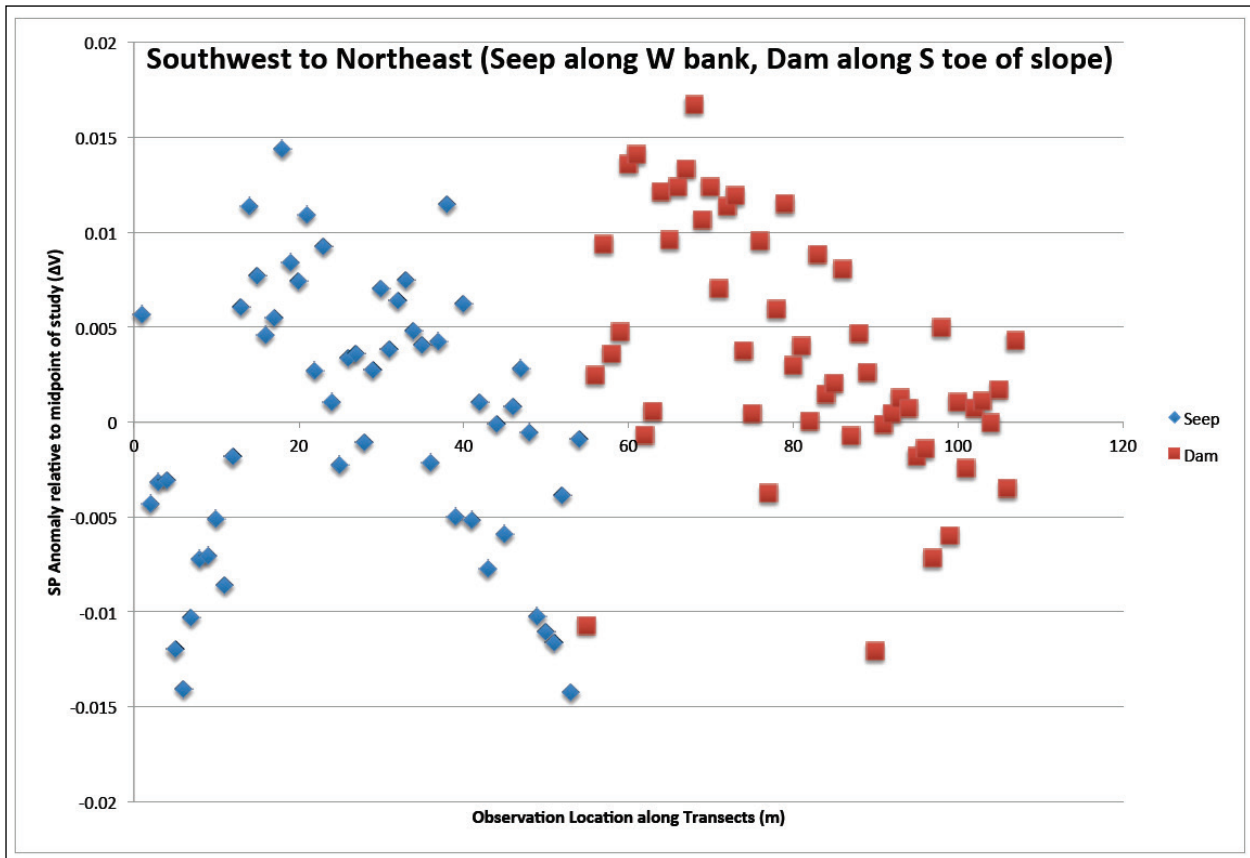
SP was used at a location south of the dam (see Appendix IV for location). SP is useful as it seeks to identify areas with increased shallow groundwater movement. The goal for the SP surveys was to help determine if subsurface flow is occurring in areas hidden below the land surface. The seep was useful as it acted as a control, relating a value to a point where flow was physically observed at the land surface. Figure 11 shows the results from the SP survey. Data are plotted to show changes in voltages across SP Surveys A and B, with all values relative to a fixed location on the west edge of the dam. Abnormally high or low results could suggest increased groundwater flow in the subsurface. The seep seen at the surface correlates to approximately the 30-37 meter range noted along the X-axis of Figure 11. SP values in this range are higher relative to the reference electrode, but results do not conclusively identify other areas of increased flow. A possible area of increased groundwater flow could be on the west side of SP Survey B, but a more probable explanation would be that such flow would be related to the existing drainage pattern of the dam.

**Figure 11.** Scatter plot showing SP results for Surveys A and B, shown southwest to northeast.
