UNDERGROUND MINES AND RELATED SUBSIDENCE POTENTIAL  
WHAT CHEER, IOWA

Paul E. Van Dorpe  
Mary R. Howes  
Marsha J. Miller  
Susan J. Lenker

Iowa Geological Survey

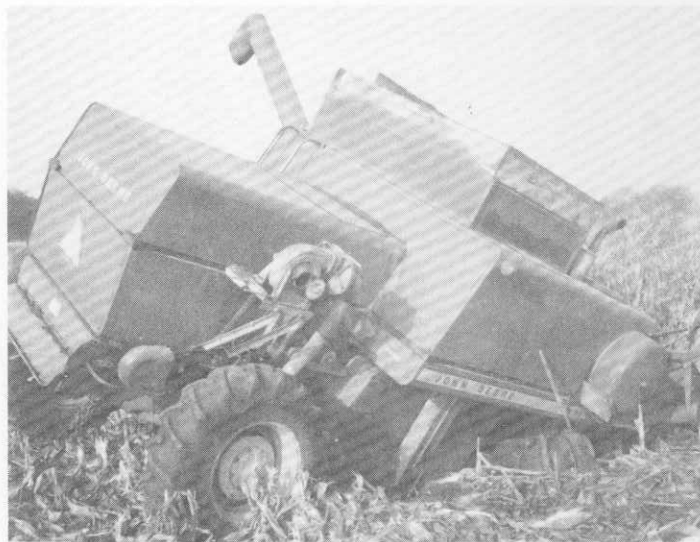
Cover Photo: Pictured is a JD 7700 combine, belonging to Lyle Molyneux and Sons, that received extensive damage October 8, 1984. The incident occurred around noon when picking corn in a field northwest of What Cheer. The right front wheel fell into a sinkhole in an old mining area. No injuries were reported and after a wrecker pulled the combine out, it was driven home.  
*Courtesy:* What Cheer Patriot-Chronical, 10-11-84.

In the fall of 1984 while picking corn northwest of What Cheer, Iowa, a combine fell into a mine-subsidence crater (see cover) above an old underground coal mine (What Cheer Patriot-Chronicle, 1984; No. 58). Fortunately, there were no injuries, but damage to the combine was estimated to be about \$2,000, (John Molyneux, 1984, personal communication). The crater, estimated to be 6 feet across and 7 feet deep, is above a room of the What Cheer Coal Company D mine, about 70 feet below the surface where the combine toppled. For the Molyneux family, this was not the first time a mine-subsidence problem has interrupted field work near What Cheer.

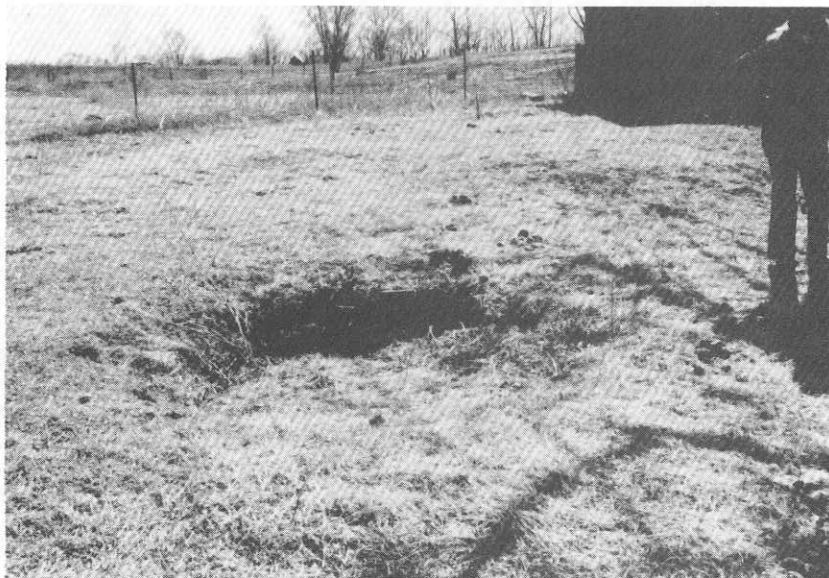
Photo No. 1 Crater in pasture south of County Road G29, NE, NE, Sec. 9, T76N, R13W. View is roughly southeast.

An investigation of the area in 1980 also revealed the presence of three craters south of the road in the pasture. Photos No. 1 and 2 show a crater approximately 15 feet in diameter in the pasture. Photos No. 3 and 4 show a larger and deeper crater near a farm pond. This crater is approximately 25 feet in diameter and about five to six feet deep. Photo No. 5 shows typical slumping of the crater walls. These craters are typical of subsidence features observed elsewhere in Iowa.

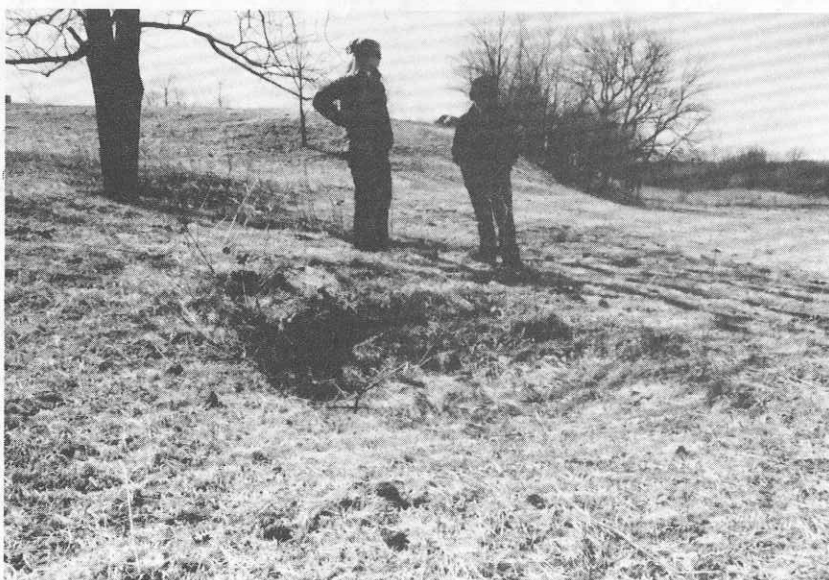
Photo No. 2 Crater in pasture south of County Road G29, NE, NE, Sec. 9, T76N, R13W. View is roughly northeast.

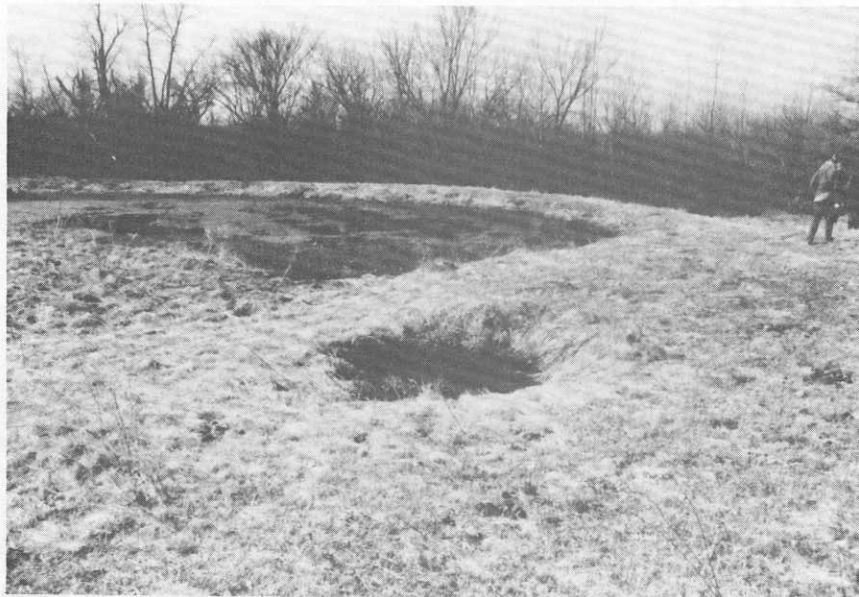
Photo No. 3 Crater in pasture above farm pond, NE, NE, Sec. 9, T76N, R13W.  
View is roughly southwest.

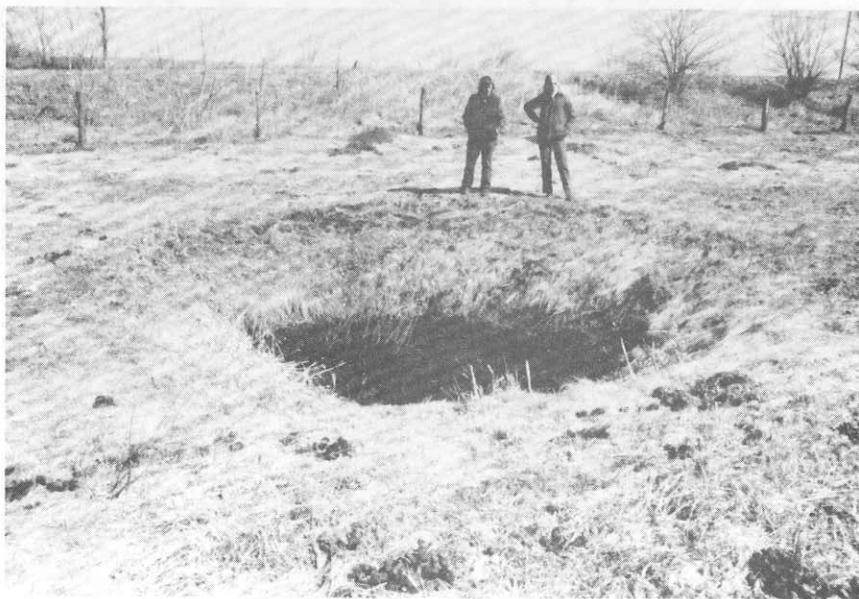
Photo No. 4 Crater in pasture above farm pond, NE, NE, Sec. 9, T76N, R13W.  
View is roughly north.

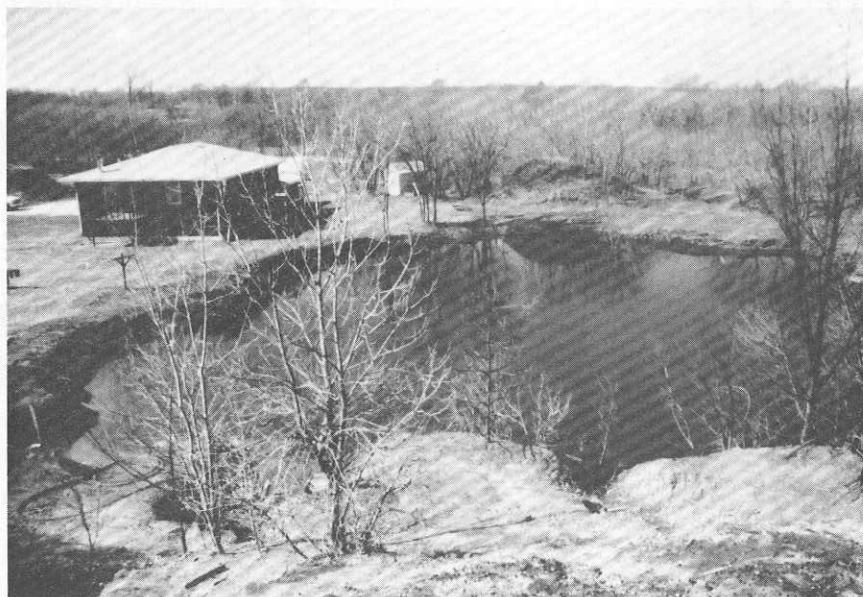
Photo No. 6 Water-filled crater, NW, NE, Sec. 9, T76N, R13W. View is roughly west.

Near the driveway and an outbuilding, an 8 by 12 foot dish-shaped depression about 2 1/2 feet deep was observed. Twenty feet from the northeast corner of the house there is a large, water-filled crater about 100 feet in diameter, and of unknown depth, which may be a collapsed mine shaft (Photo No. 6). The water level in this crater has been observed to fluctuate in conjunction with water levels in a nearby strip pit, estimated to be 40 to 60 feet deep. The hydraulic connection between the two probably exists beneath the house. Older residents of the area have reported that when the strip pit was in operation, some old underground mine works were "broken into," presumably along the north and east sides of the strip pit.

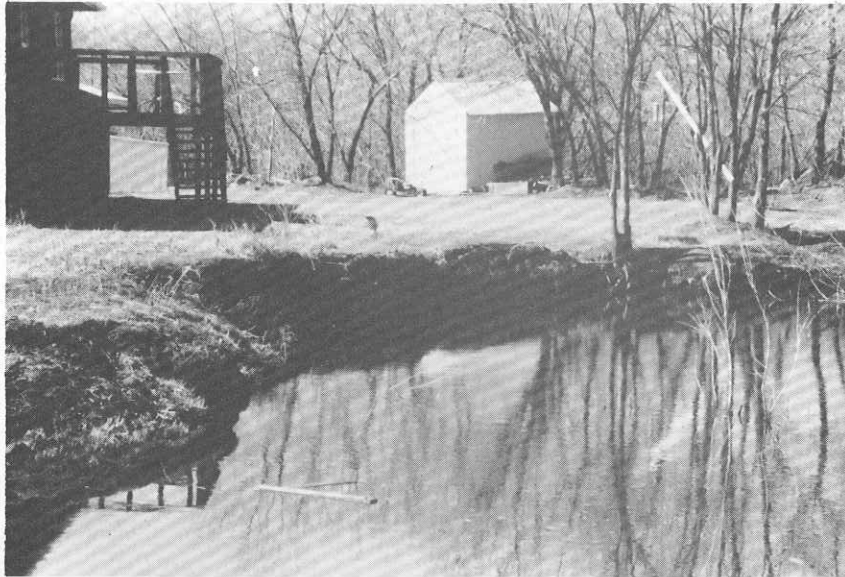
Photo No. 7 Trees submerged within crater, NW, NE, Sec. 9, T76N, R13W. View is roughly west.

Although no caving of the sides of the large water-filled crater has been observed by the residents, field evidence suggests that slumping of the crater walls had taken place, probably just prior to the occupation of the house. Photo No. 7 shows submerged trees about 15 to 20 feet from the shoreline suggesting that the shore line receded by at least this distance. Photo No. 8 shows the steep banks, an undermined tree, and ground cracks at the edge of the crater, indicating that slumping has occurred relatively recently and will occur again. Further slumping will probably jeopardize the house.

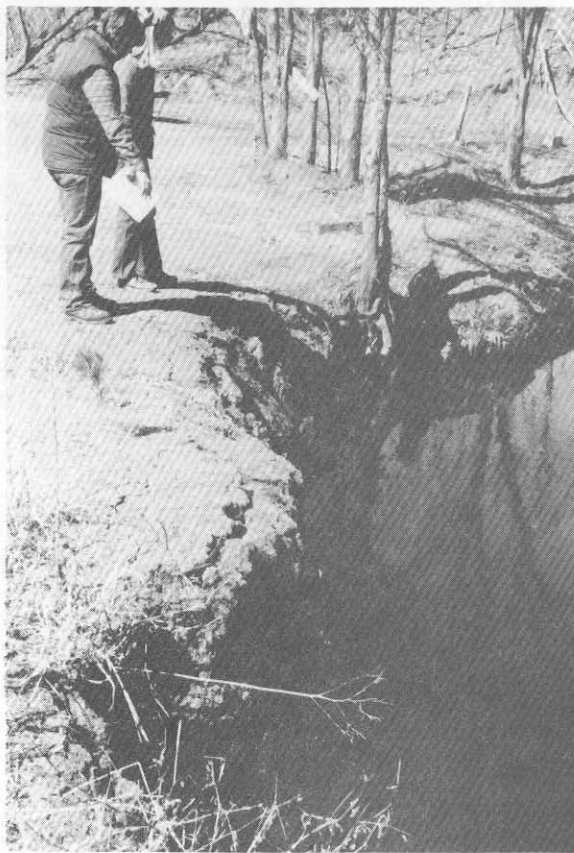
Photo No. 8 Undermined tree, steep bank, ground cracks on edge of water-filled crater, NW, NE, Sec. 9, T76N, R13W. View is roughly northwest.

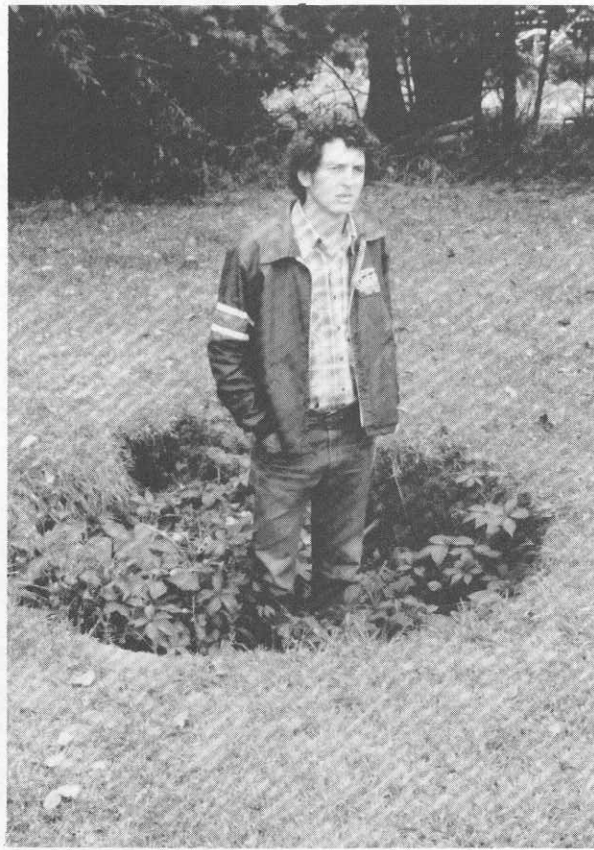
Photo No. 9 Crater above What Cheer Coal Co. F., SW, NE, SW, Sec. 10, T76N, R13W. View is roughly southeast.

Over an area marked as "old works" on the What Cheer Coal Co. F mine map, there are at least eight identifiable collapse features (craters) on the surface in an area about 100 feet by 50 feet. Photo No. 9 shows the most recent of these which developed in the spring of 1984 (M. Patrick McAdams, 1984, personal communication). Photo No. 10 shows arcuate fractures (beneath pencil in photo) which indicate that the crater has not yet stabilized. The crater is about seven feet in diameter, and varies from two feet to four feet deep.

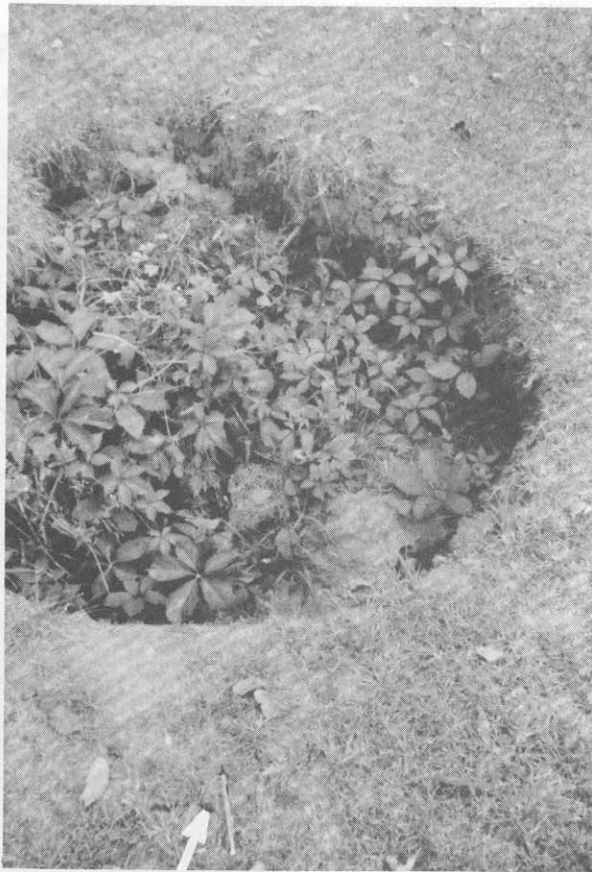
Photo No. 10 Fracture and crater above What Cheer Coal Co. F., SW, NE, SW, Sec. 10, T76N, R13W. View is roughly southeast.

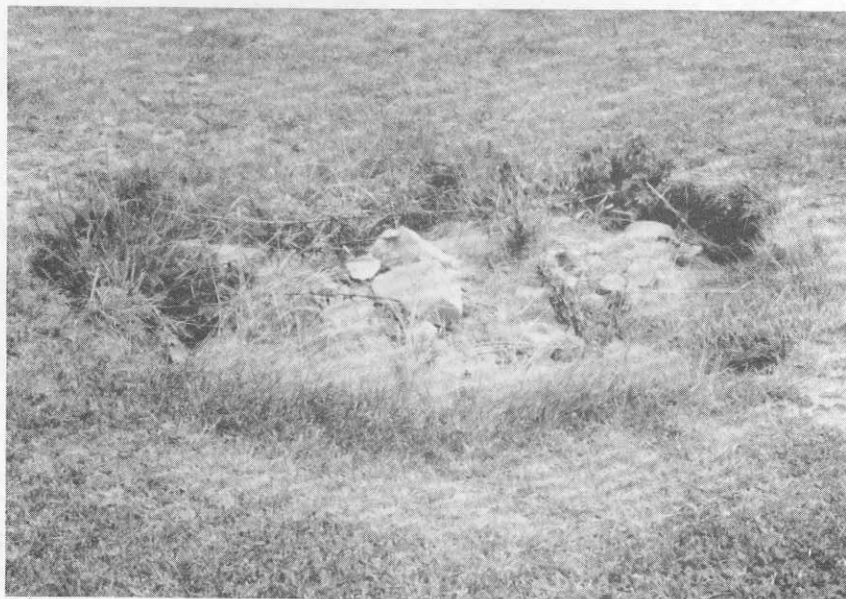
Photo No. 11 Crater above What Cheer Coal Co. F., SW, NE, SW, Sec. 10, T76N, R13W. View is east.

Another collapse crater (Photo No. 11) approximately two years old (M. Patrick McAdams, 1984, personal communication), appears to have been partly filled. Other, apparently older and, at least currently, stable, craters pockmark the field. The layout of the mine is suggested by the regular spacing of these craters.

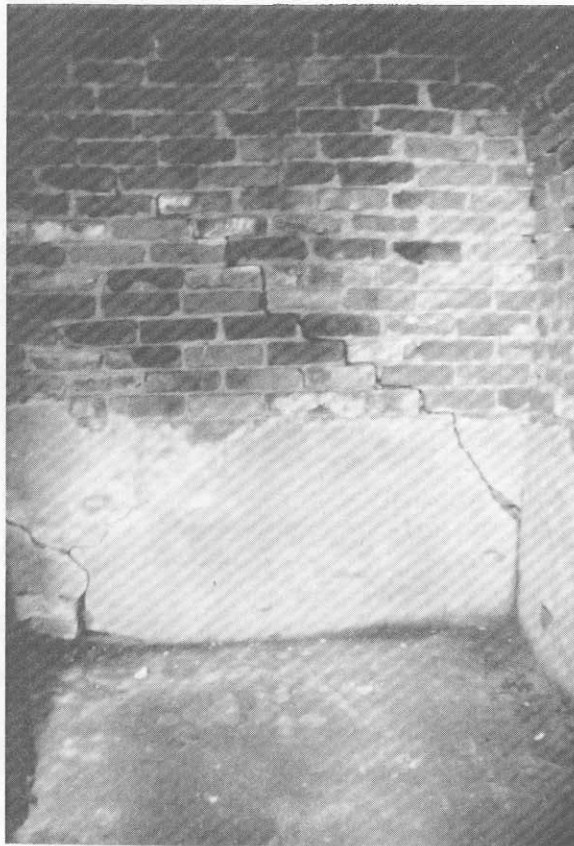
Photo No. 13 Interior of root cellar, north wall, above What Cheer Coal Co. F., NE, NW, SW, Sec. 10, T76N, R13W. View is north.

Another suspected collapse crater occurs outside a root cellar (Photo No. 12). The wall adjacent to the surface crater is badly cracked and the floor is tilted down beneath and toward the crater (Photo No. 13).
